**DEPARTMENT OF TRANSPORTATION**

Contract #: 04-0120F4Cty: SF/ALA Rte: 80 PM: 13.2/13.9File #: 69.28**WELDING INSPECTION REPORT****Resident Engineer:** Pursell, Gary**Address:** 333 Burma Road**City:** Oakland, CA 94607**Report No:** WIR-007518**Date Inspected:** 13-Jun-2009**Project Name:** SAS Superstructure**OSM Arrival Time:** 700**Prime Contractor:** American Bridge/Fluor Enterprises, a JV**OSM Departure Time:** 1900**Contractor:** Zhenhua Port Machinery Company, Ltd (ZPMC), Changxing Island **Location:** Shanghai, China**CWI Name:** Xu Le Feng, Liu Yang**CWI Present:** Yes No**Inspected CWI report:** Yes No N/A**Rod Oven in Use:** Yes No N/A**Electrode to specification:** Yes No N/A**Weld Procedures Followed:** Yes No N/A**Qualified Welders:** Yes No N/A**Verified Joint Fit-up:** Yes No N/A**Approved Drawings:** Yes No N/A**Approved WPS:** Yes No N/A**Delayed / Cancelled:** Yes No N/A**Bridge No:** 34-0006**Component:** TOWER**Summary of Items Observed:**

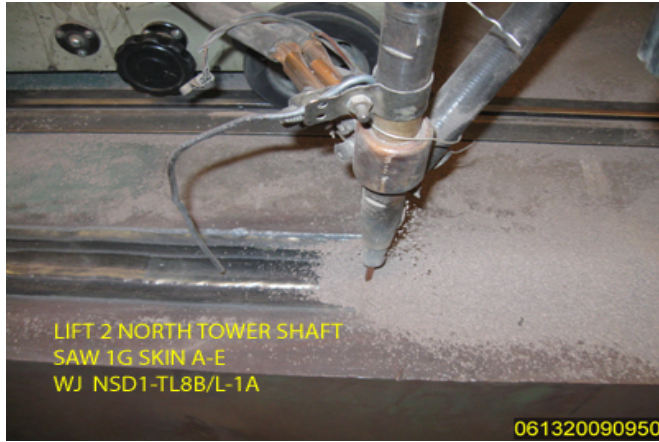
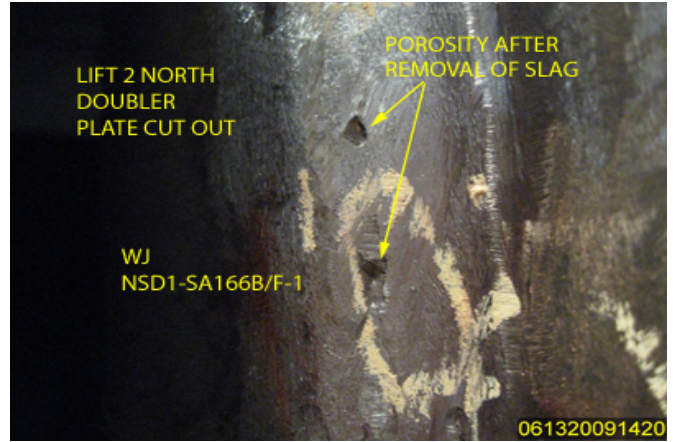
The QA Inspector performed a 100% VT Inspection and 15% Magnetic Particle Testing (MT) Verification of the welds attaching doubler plates to Lift 2 North Tower Shaft Skin Plate A per ZPMC NDT Notification Sheet 003403. The QA Inspector visually observed several areas which required grinding and one area in the cutout at WJ NSD1-SA166B/F-1 which required grinding to remove several mm of aligned slag pockets and then welding to fill the excavation. There appeared to be no indications after the re-work and the QA Inspector accepted the above listed welds. The attached photographs provide additional detail.
